Microbial water quality in clean water tanks following inspection and cleaning

Sarah C.B. Christensen*, Anne Esbjørn**, Finn Møllerup** & Hans-Jørgen Albrechtsen*
*DTU Environment, Technical University of Denmark, ** VCS Denmark

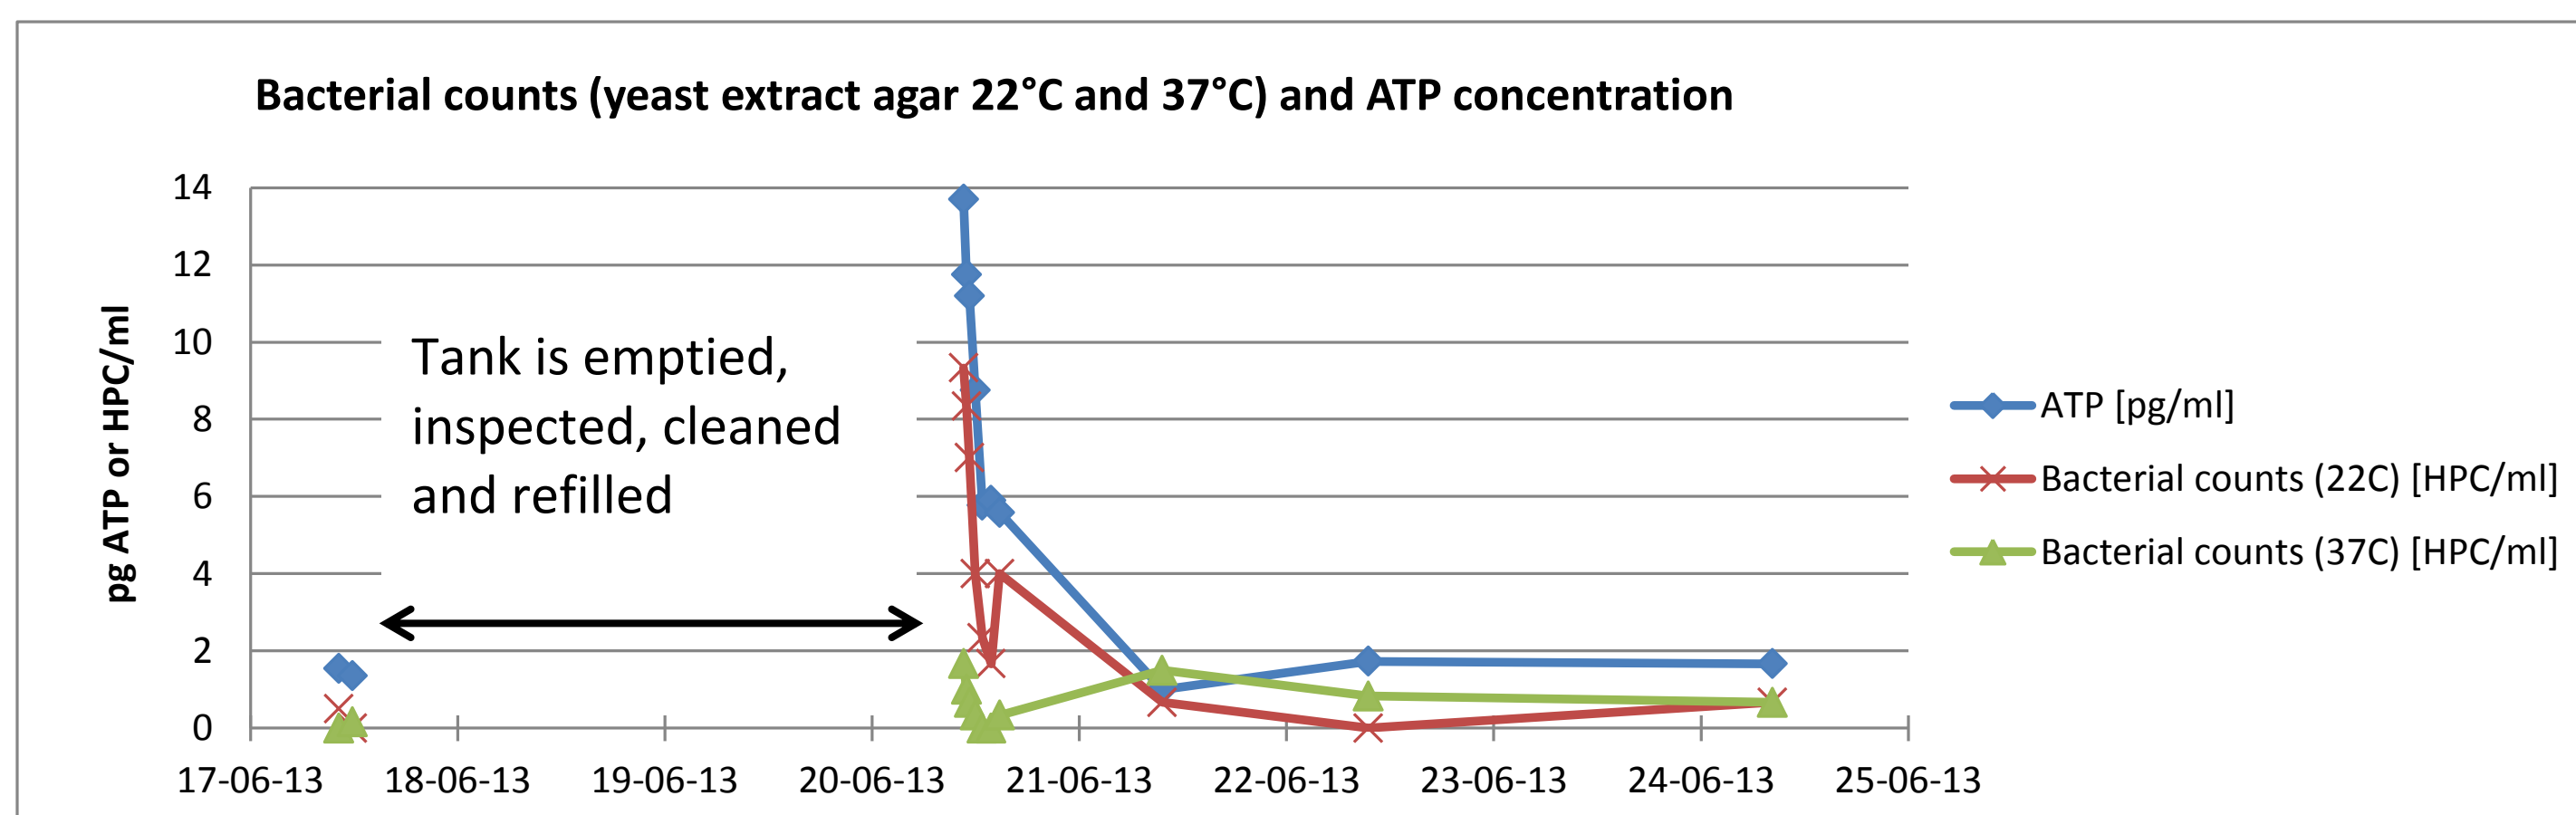
Concentration of ATP and bacterial counts [yeast extract agar, 22 and 37°C] in water leaving clean water tank from the main water works at VCS Denmark

Bacterial counts [yeast extract agar, 22°C] increased slightly after cleaning of the tanks, but did not exceed guideline values at any point during the investigations. Immediately after start-up, a maximum of 10 CFU/ml (Colony Forming Units) were measured in both tanks, and after less than

24 hours the concentrations were below 1 CFU/ml in both tanks. The low concentrations were maintained the following days. Bacterial counts [yeast extract agar, 37°C] were below 2 CFU/ml at all times.

To include bacteria not normally quantified by traditional methods, such as plating, we included ATP (Adenosin-Tri-Phosphate) measurements of the water. ATP is present in all living bacteria. ATP concentrations in the water immediately after start-up were high compared to the concentration of culturable bacteria which may indicate that bacteria from the sand filter e.g. nitrifying bacteria, which normally grow on substrates not present in the agar, were present in the water.
